Assessment of Paint Layers by FE-SEM and EDS Examination

ARL-TR-3232

June 2004

Weapons and Materials Research Directorate, ARL

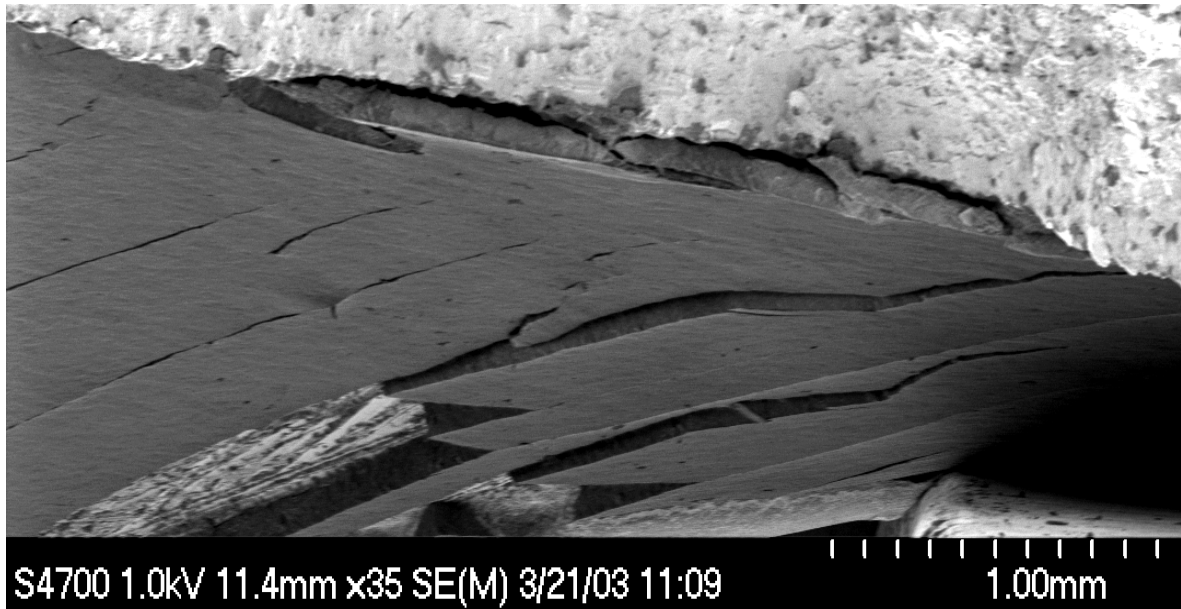
The segment from panel 7 could not be oriented to properly image the film cross section at higher magnifications above 1 KX. The way the surface coating shattered (figure 5) added to the orientation problem by inhibiting some surface electron drain, thereby increasing the surface charging at higher magnifications.

Figure 5. Panel 7 at 35× FE-SEM. Coating film is the darker area.

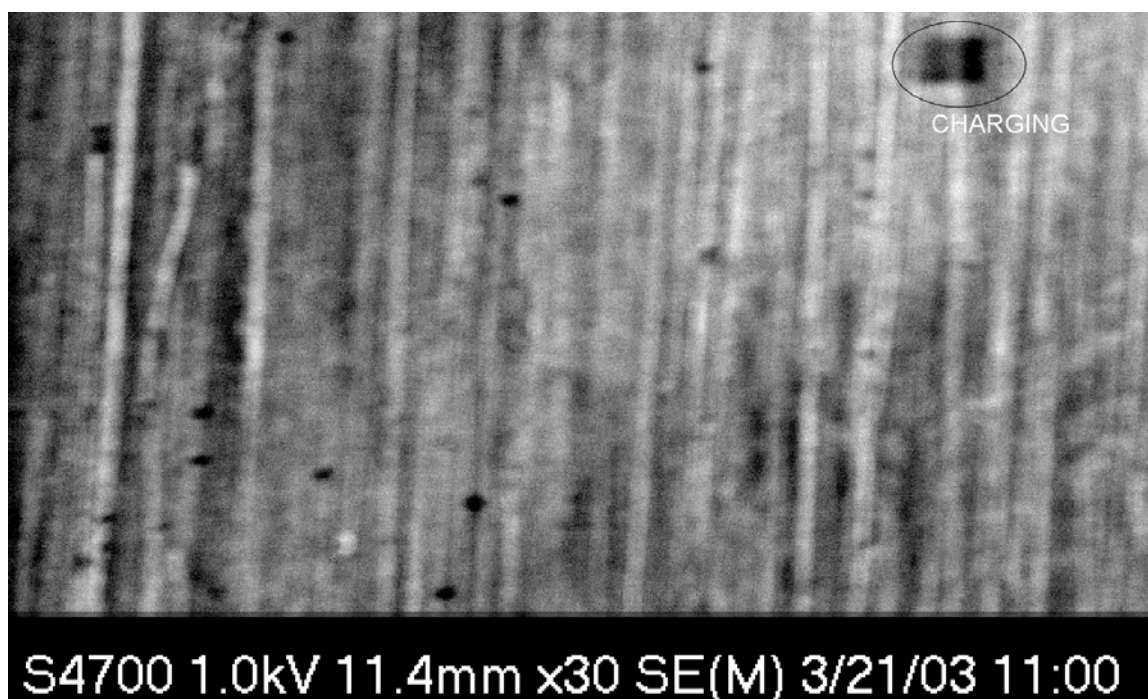
mount were insufficient to the required task. One result of this problem is seen in figure 32, where surface charging is obvious on the aluminum micro-vise mount. The emission current was 2 μ A, and the numerical aperture value was 5.5.

Figure 32. Surface charging on surface of aluminum micro-vise.
